Final Report  
*Platino* Accident  
13 June 2016

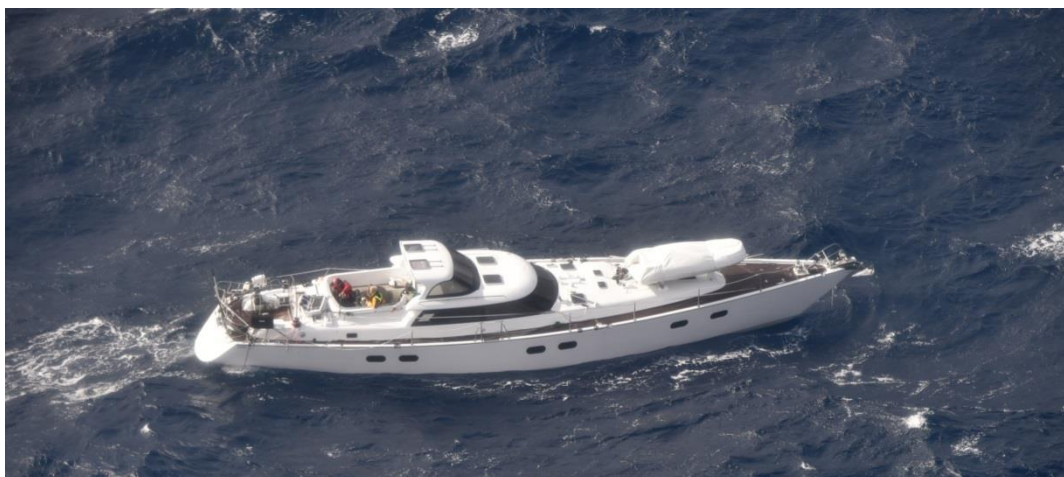
**Figure 1** Tuesday 14 July – **Platino** with surviving crew waiting in cockpit prior to rescue

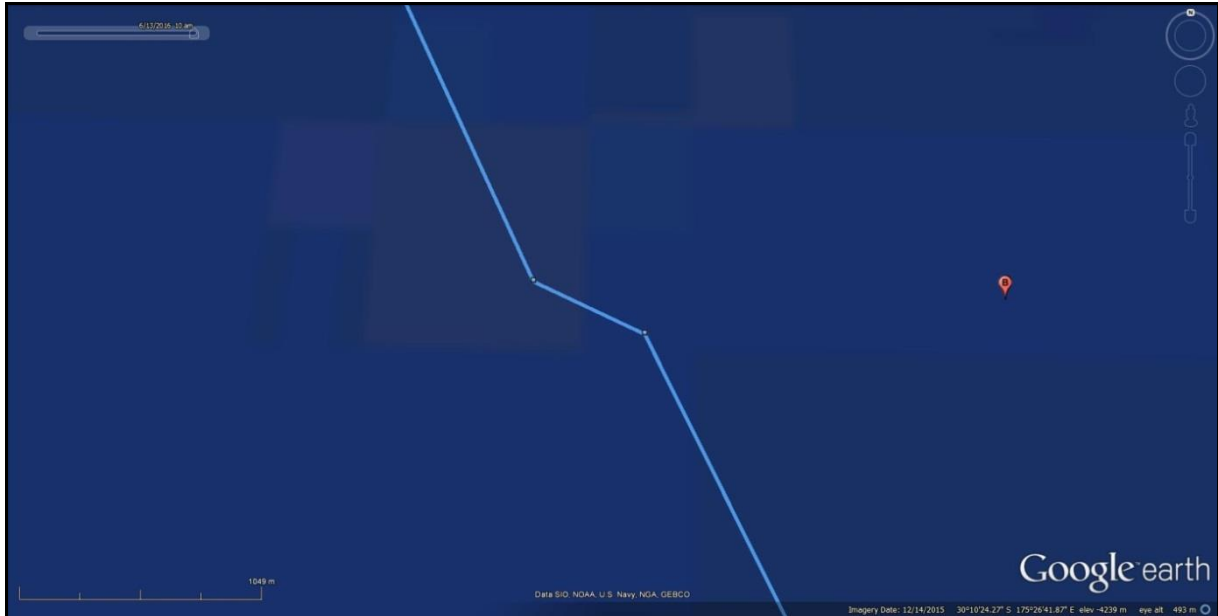
This event occurred 28.8 nautical miles before the position of the accident. The estimated time is approximately 0748 AM or 3 hours, 12 minutes before accident. The track alters from 334° to 295° for 63 metres before returning to 335°. This was a 39° deviation to port for 13 seconds based on an average speed of 9 knots.

**Figure 3** Steering event 28.8Nm prior to the crash gybe

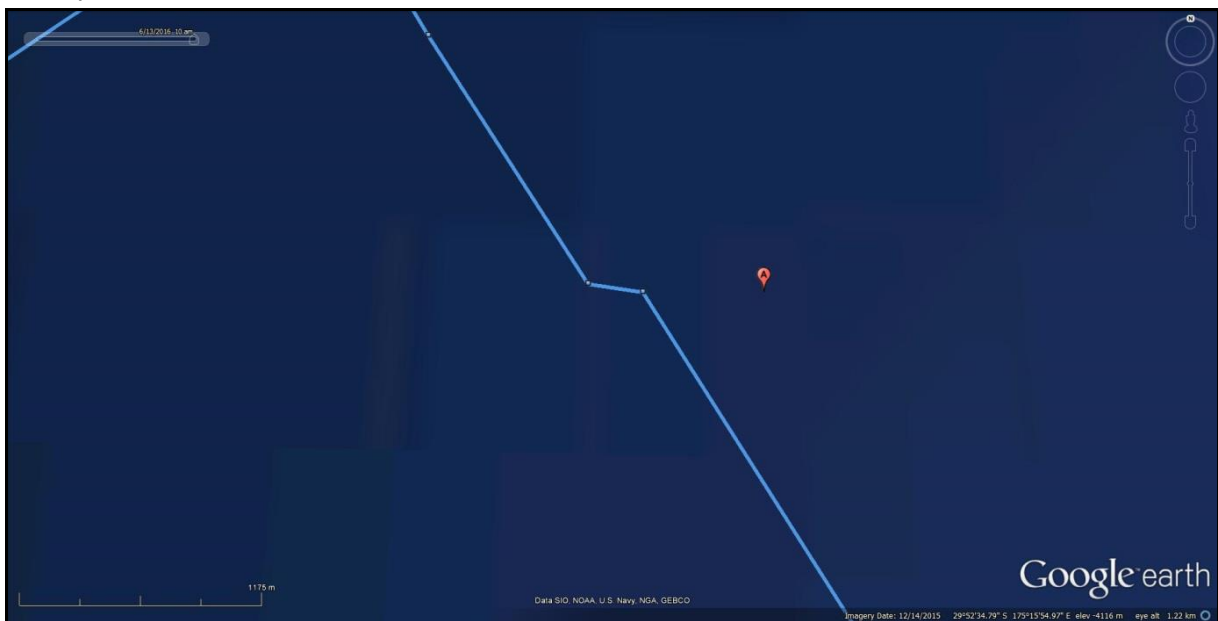
This event occurred 6.9 miles before the position of the accident. The estimated time was approximately 1014 AM or 46 minutes before the accident. The track altered from 328° to 278° for 68 metres before returning to 327°. This was a 50° deviation to port for 15 seconds based on an average boat speed of 9 knots.

**Figure 4** Steering event 6.9Nm prior to the crash gybe

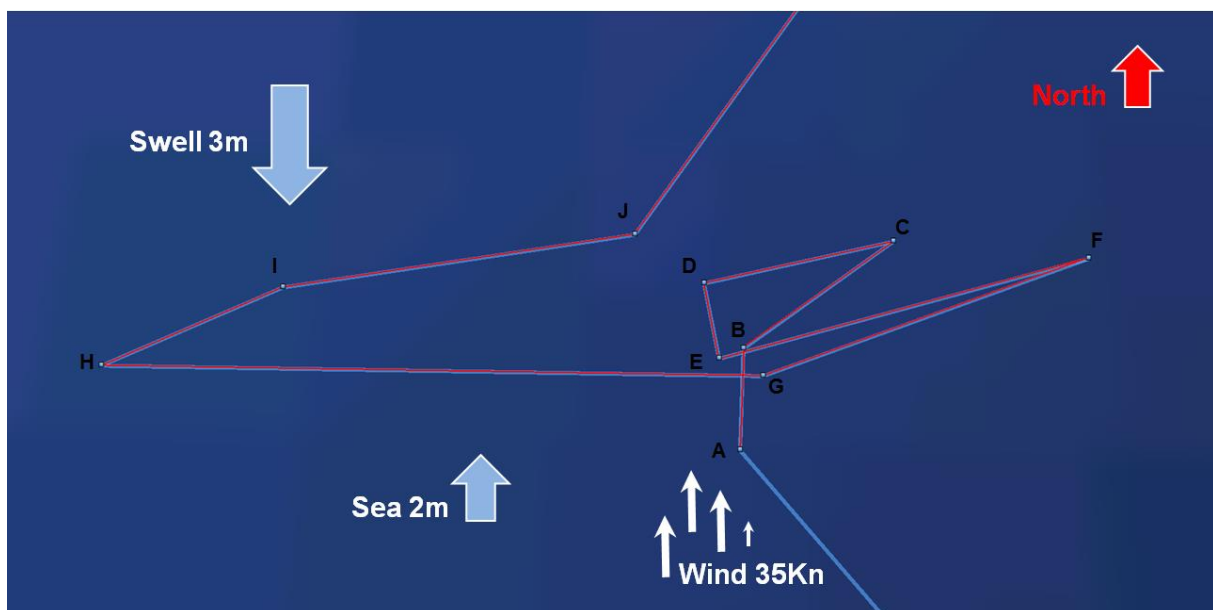
The GPS track information illustrated below shows the path **Platino** followed during the first few minutes of the accident. The yacht travelled along the line from the bottom of the picture and through the series of recorded track points (labelled A to J) before exiting at the top. The initial crash gybe occurred when **Platino** made a significant and unintentional turn to starboard (labelled A) while sailing at approximately nine knots. After this point, the yacht would have slowed, and is likely to have come to a complete stop at times. The distance between the track points was known but the time taken to travel between these could only be estimated based on assumed speed. The actual heading of the yacht was likely to be generally correlated with the path but cannot be assumed to be identical, especially at low speed.

**Figure 5** Detailed GPS track information showing **Platino's** path through the accident rate

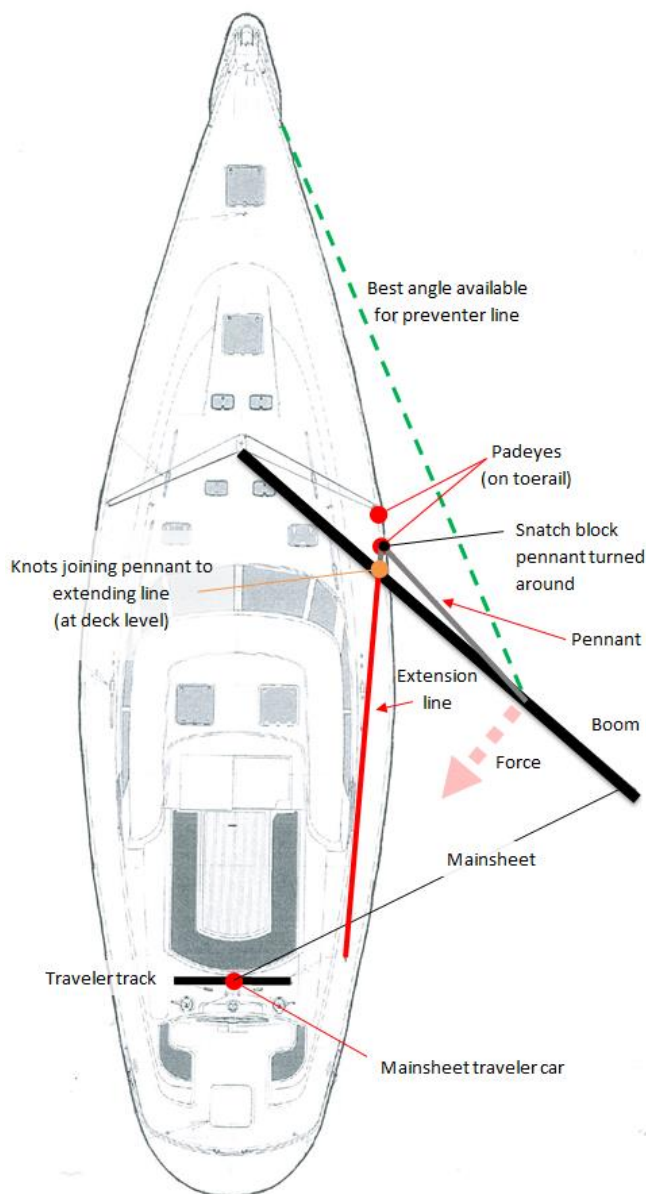
**Figure 6** Actual deck plan of **Platino** showing an impression of the preventer rigged by the crew and a more ideal angle for strength

This illustration of the preventer arrangement (above) was created, based on the crew's statements and information gathered during examination of the yacht. The representation was confirmed as accurate by the surviving crewmembers.

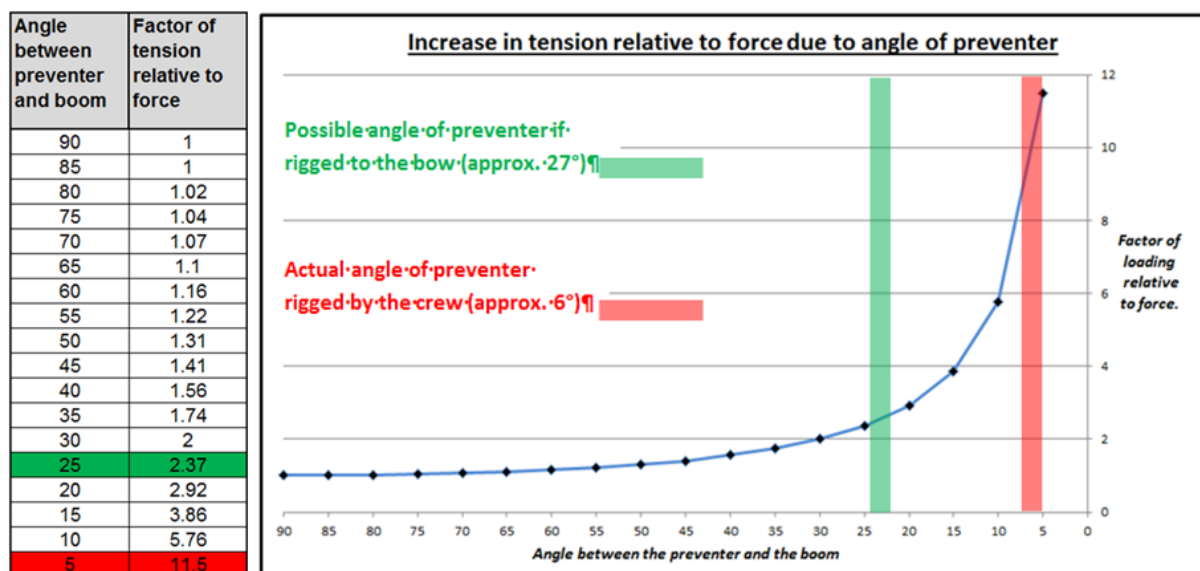
**Figure 7** Graph and table indicate the relation between the angle of the preventer rigged from the boom and the resulting force

This graph illustrates how the load pulling on the preventer is inversely proportionate to the angle between the preventer and the boom. The load on the preventer line would be the force (acting

through the boom where the preventer was attached), multiplied by the factor of loading relative to force. This is of minimal consequence at angles as low as  $25^\circ$  from the boom, where the load on the preventer would be about 2.4 times the force on the boom. However, the effect increases exponentially as the angle approaches  $0^\circ$ . In practice a  $90^\circ$  angle is virtually impossible to achieve. However, acute angles should be avoided.

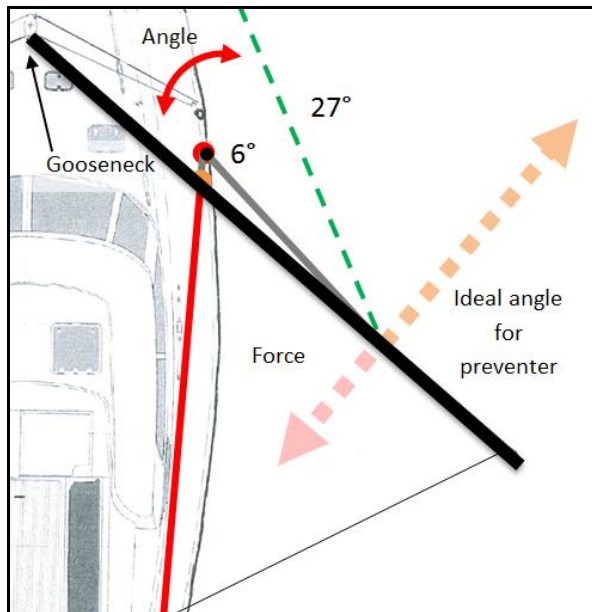
**Figure 8** Impression of the preventer arrangements showing approximate angles

The diagram of **Platino's** preventer above shows the approximate angles of a preventer line led forward to the bow (the best case scenario) and the actual arrangement of the preventer rigged by the crew.

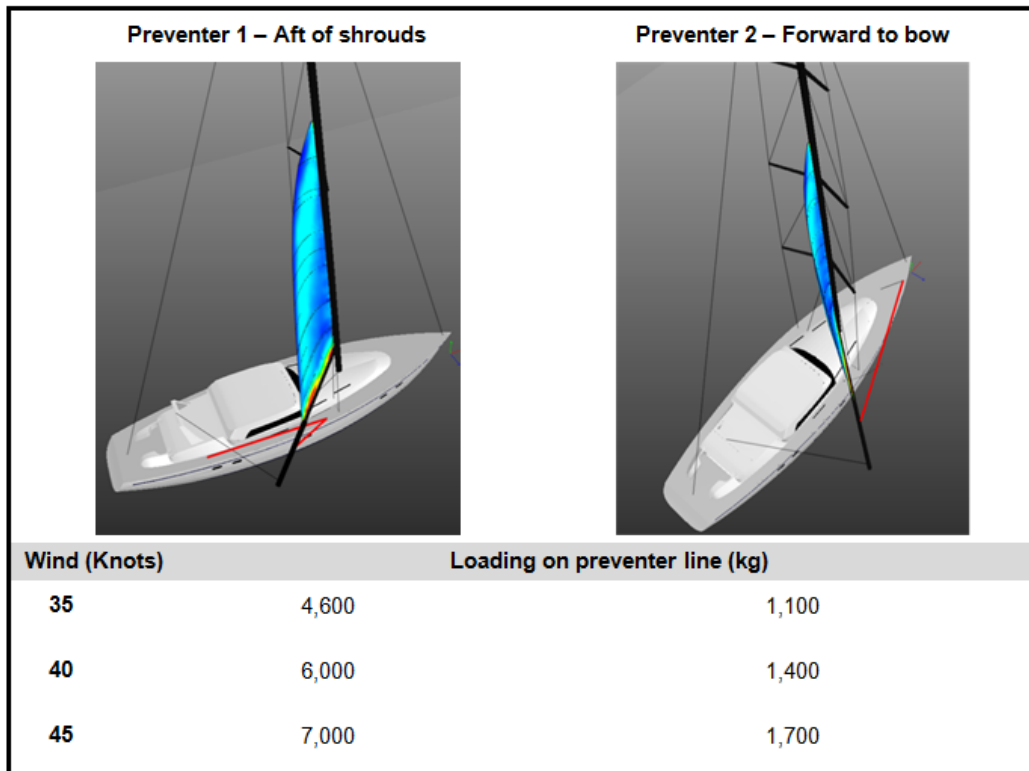
**Figure 9** Computer simulation showing calculated preventer loads based on scenarios provided by this investigation

In the simulation above, Preventer 1 represents the actual arrangement rigged by the crew, which was anchored on the padeye fixed to the toe rail aft of the shrouds. Preventer 2 represents the best case scenario of leading the line as far forward on the bow as possible.

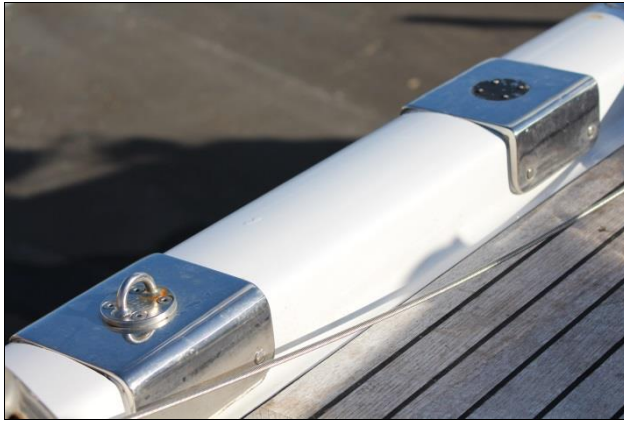
**Figure 10** Starboard toerail showing padeyes

*This photo shows the saddles and padeyes that were fitted to the starboard toerail during the refit. Note the after-most of the two padeyes (right) is missing from the saddle*

- The padeye was fitted for outboard sheeting of the jib and was not intended for use in anchoring a preventer.
- The padeye fitted had a safe working load lower than that recommended by the supplier of the updated sail wardrobe, which had recommended the padeyes be fitted.

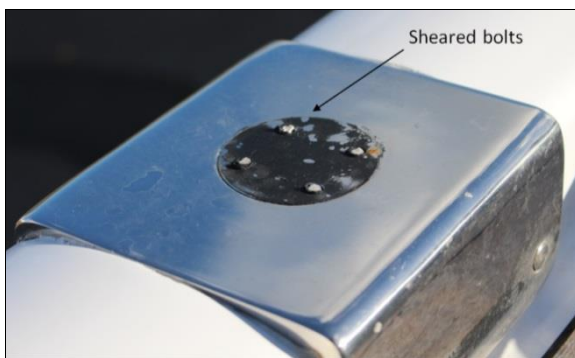
The next weakest part of the preventer was the padeye on the toerail, with a breaking load of 4,080kg. The four 6mm stainless steel bolts used to secure the padeye to the saddle on the toe rail sheared through the thread, when the knots tied in the preventer line became stopped off against the snatch block.

**Figure 11** Starboard aft toerail saddle, sheered padeye

The 57mm padeye used to anchor the preventer was one of four fitted to the toe rails during the refit. The padeyes were placed at the recommendation of the sail supplier and were intended to be used for outboard sheeting of the jib<sup>35</sup>. The padeyes were not intended to be used to anchor a preventer, which was likely to involve substantially higher loads. Despite the relatively lower loads expected for outboard jib sheeting, the sail supplier recommended padeyes with a safe working load of four tons be used. Based on this, 76mm padeyes with a safe working load of 4,705kg and a breaking load of 9,430kg were selected. These would have allowed a substantial safety margin for the intended purpose. The 76mm padeyes specified have more than double the strength of the 57mm padeyes that were fitted.

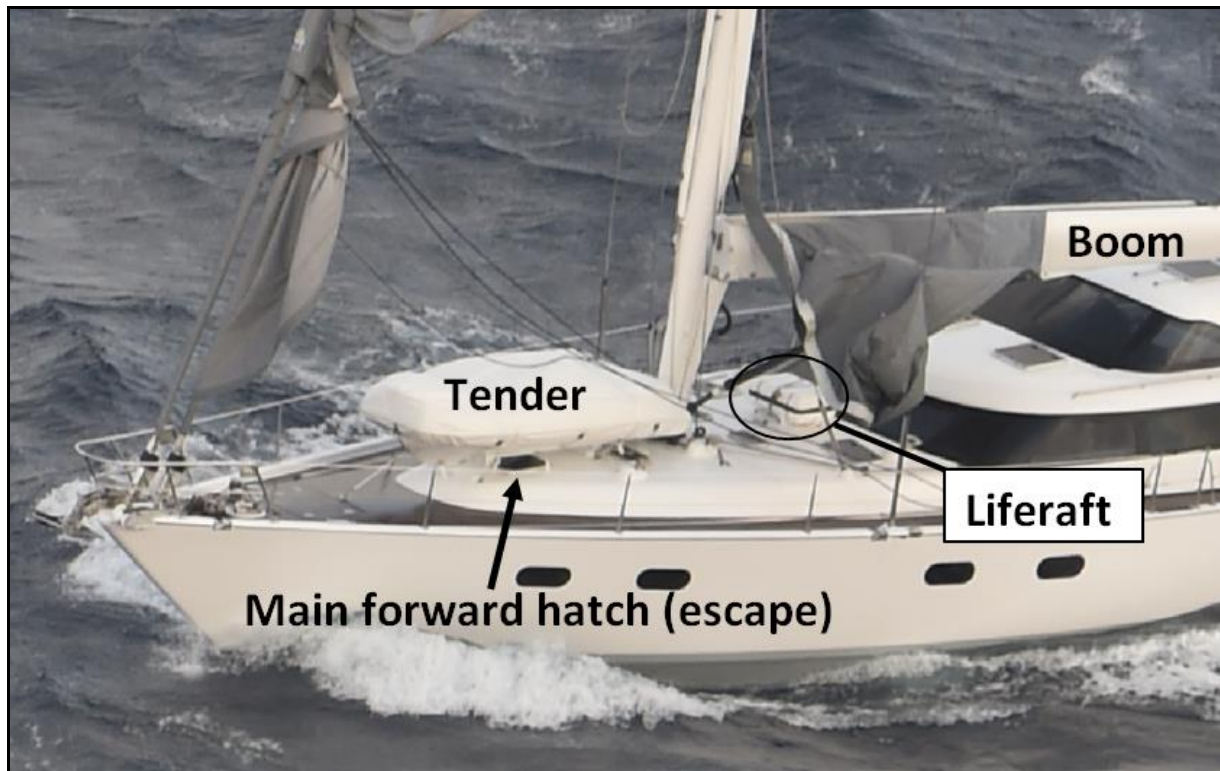
**Figure 15** *Platino* 13 June following the initial crash gybes.

In the first few minutes that followed the initial crash gybe, *Platino's* jib (headsail) and sheets were flogging uncontrollably over the foredeck area. No adjustments were made to the jib and it may have rendered the foredeck inaccessible to the crew until the sail disintegrated sometime later. The boom's repeated impacts on the shrouds also had the potential to topple the mast at any time and any crewmember on the bow would have been completely exposed.

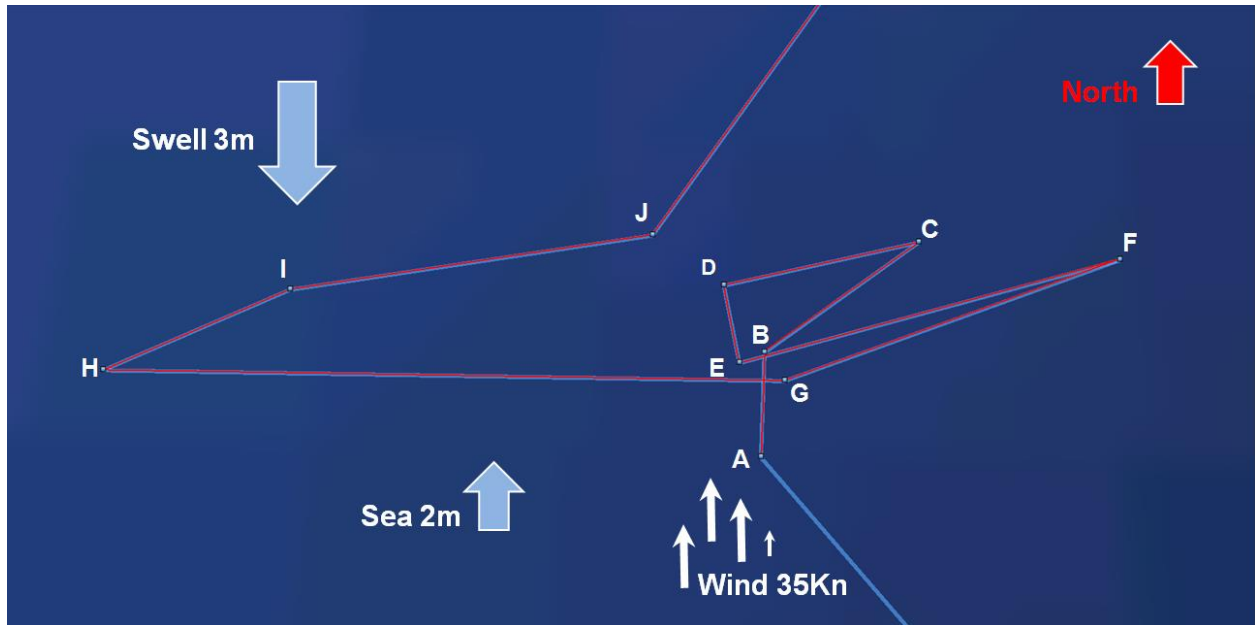
Track data points recorded previous to the event below are evenly spaced and show a consistent path, generally with very little variance. The track shown below shows a dramatic change in the yacht's behavior and indicates the path the yacht travelled through the scene of the accident. The first uncontrolled gybe is known to have occurred at approximately 1100 AM on 13 June 2016 and was caused by a substantial turn to starboard.

**Figure 17** GPS track information from accident site, wind and sea information added.

The picture above shows 10 distinct alterations in the direction of **Platino's** path, which are labeled A to J. The distance between the track points is known but the time taken to travel between these can only be estimated based on assumed speed. The actual heading of the yacht is likely to be generally correlated with the path but cannot be assumed to be identical.
