Final Report  
*Platino* Accident  
13 June 2016

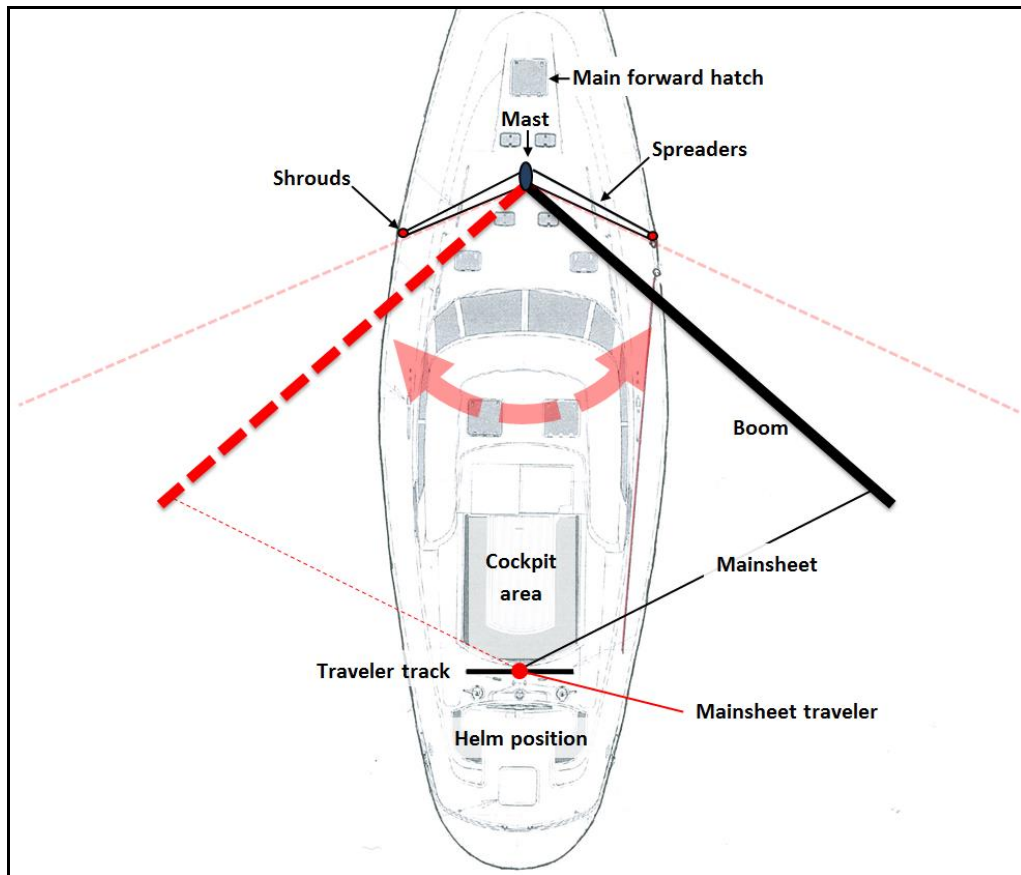
**Figure 14** *Platino* deck plan drawing showing position of mainsheet traveler

The force of the swinging boom was sufficient to break the mainsheet traveler controller and the traveler car then broke free of the track. The complete failure of the traveler arrangement left the boom swinging from side to side with the mainsheet and traveler hardware hanging from its outboard end. The motion of the boom was now only restricted by the boom hitting the shrouds<sup>10</sup> on either side of the mast.

seating in the cockpit area when the boom was eased out. **Platino's** crew stated the mainsheet traveler was not moved from its central position during the voyage toward Fiji.
